Plastic Ball Grid Arrays

Application Overview:

The inspection of plastic ball grid array (BGA) devices using SAM equipment is very common. Failure modes such as moisture-induced cracking, or popcorning, and delaminations are the most common. Below you can see a variety of the types of defects that can be found with a Sonix SAM system. Automated inspections are possible, but most inspections are done in FA or process control environments.

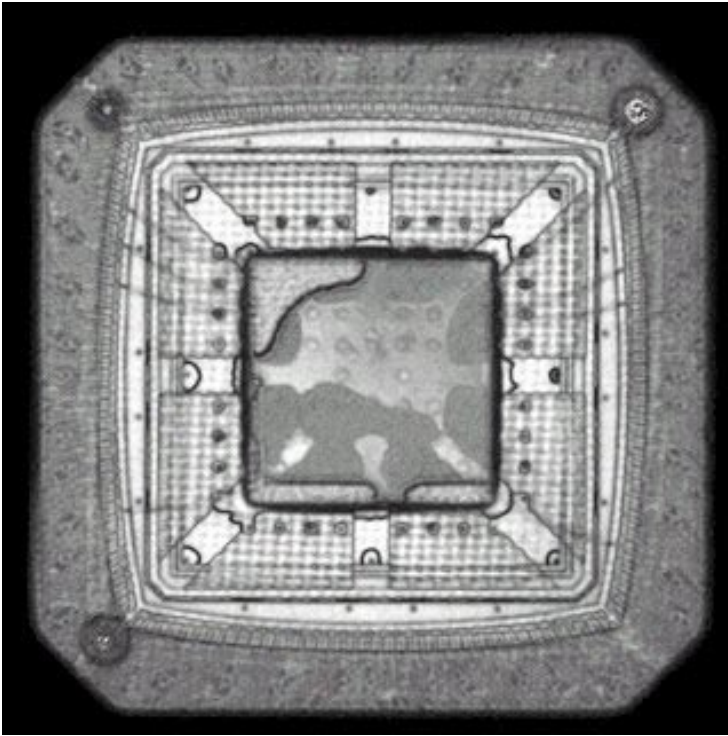
This is a pulse-echo (reflected) mode image of the top side of a ball grid array (BGA) package. A 75MHz 12mm focal length transducer created this image. This peak amplitude interface image displays information regarding the bond quality of the die top, die attach, die pad and encapsulant to substrate interfaces. The bright white area in the center square representing disbonds between the encapsulant and die. Disbonding on the top of the die will cause the bond wires to not make an adequate electrical connection. Disbonding can also be found between the die attach and heat sink. This disbonding was likely caused by an insufficient amount of attach material, however, improper force in attaching the heat sink could also be a cause.

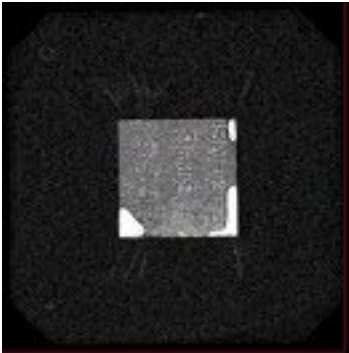
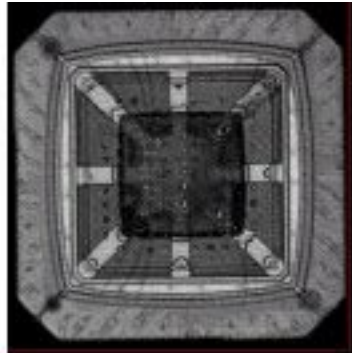
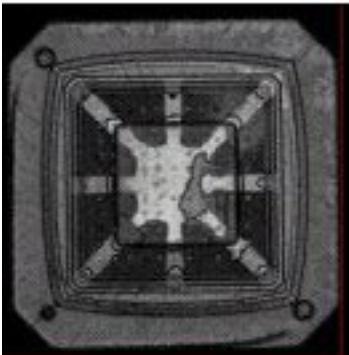
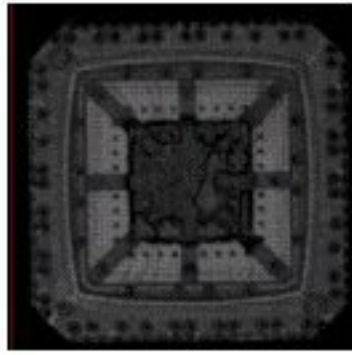
This is a pulse-echo (reflected) mode image of a Ball Grid Array package. A 75MHz 12mm focal length transducer created this image. This peak amplitude TAMI™ Scan image shows all four layers of primary interest in this BGA. Bright white areas in the upper left image represent disbonds between the encapsulant and die. Disbonding on the top of the die will cause the bond wires to not make an adequate electrical connection. Disbonding can also be found between the die attach and heat

sink, as seen in the upper right and lower left images. This disbonding was likely caused by an insufficient amount of attach material, however, improper force in attaching the heat sink could also be a cause.

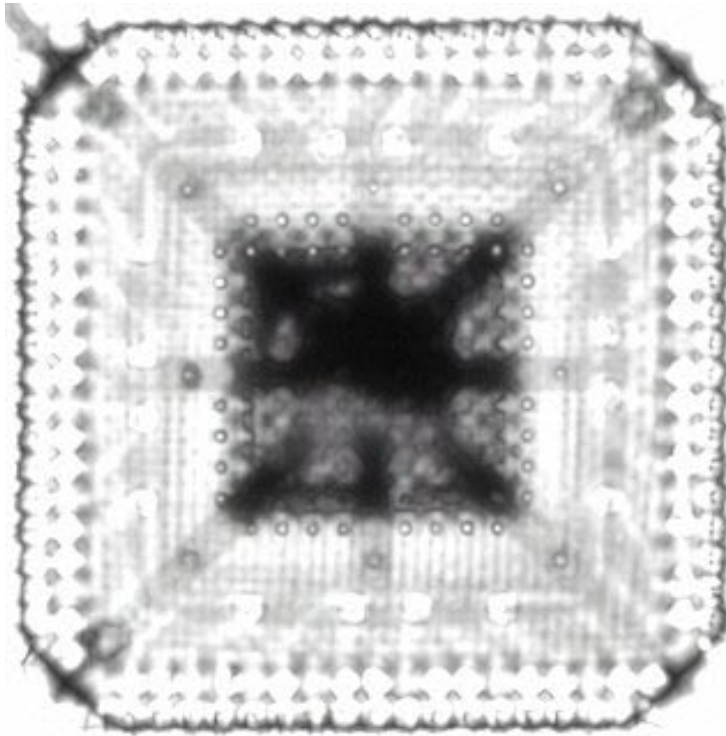
This is a Through Scan image of a BGA package. A 75MHz 12mm focal length transducer created this image. This peak amplitude image displays information regarding the bond quality of all the interfaces and materials within the package. Dark areas represent all types defects within the package. Further investigation is required to determine what layer the defects are occurring. Typically, through transmission imaging is performed as a confirmation technique of results obtained using pulse-echo imaging methods. Comparing this image to the previous images confirms of all previously detected defects.

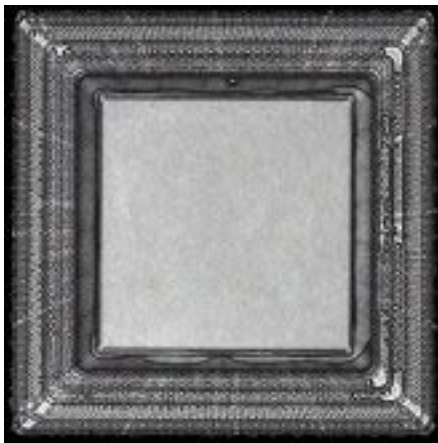
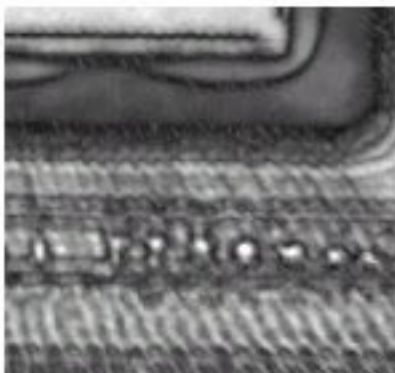
This pulse-echo (reflected) mode image is of a plastic encapsulated ball grid array device. The lower image is just a zoomed section of the upper image. In this inspection, concern was raised if excess die attach material, upon expansion, would wick up the side of the die and cause die top delamination. The coefficient of thermal expansion of the die attach material can cause a very small, but significant separation of the encapsulant material from the side of the die. If the excess material wicks up the side of the die too high, the delamination can propagate on top of the die, causing device failure. Research has shown that wicking in excess of 0.8 times the height of the die can directly lead to device failure. Acoustic inspection becomes necessary when a new process or material is used to ensure excess die attach wicking does not occur. Due to the vertical geometry of the wicked attach material, the height of the material can not be directly imaged acoustically, however a technique co-developed by Sonix and the packaging industry has shown a relationship between the base width of the excess material and the height of the attach material.
